Investigation of the Column Capital Volute Failure at the
Jefferson Memorial, Washington, D.C.

Elaine S. McGee

Open-File Report 96-518

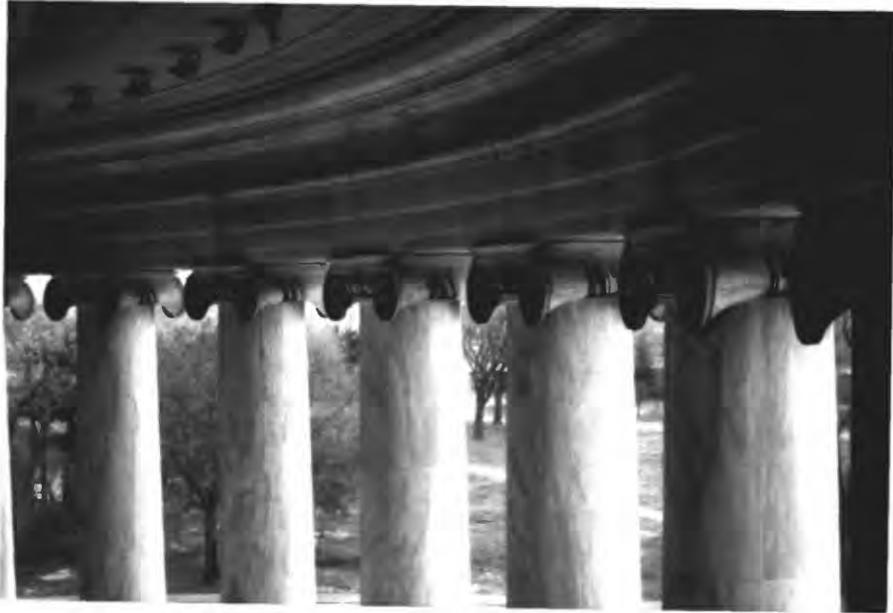
Fig. 3 Photograph of column capitals at Jefferson Memorial, showing inclusions (dark linear traces) in marble

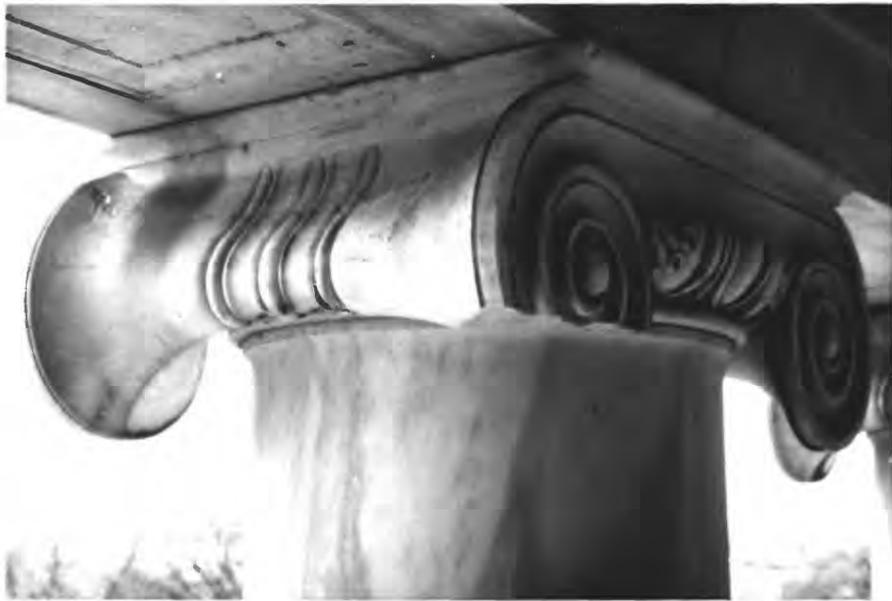
Fig. 4 Photograph of column capital (#40) with broken volute A.

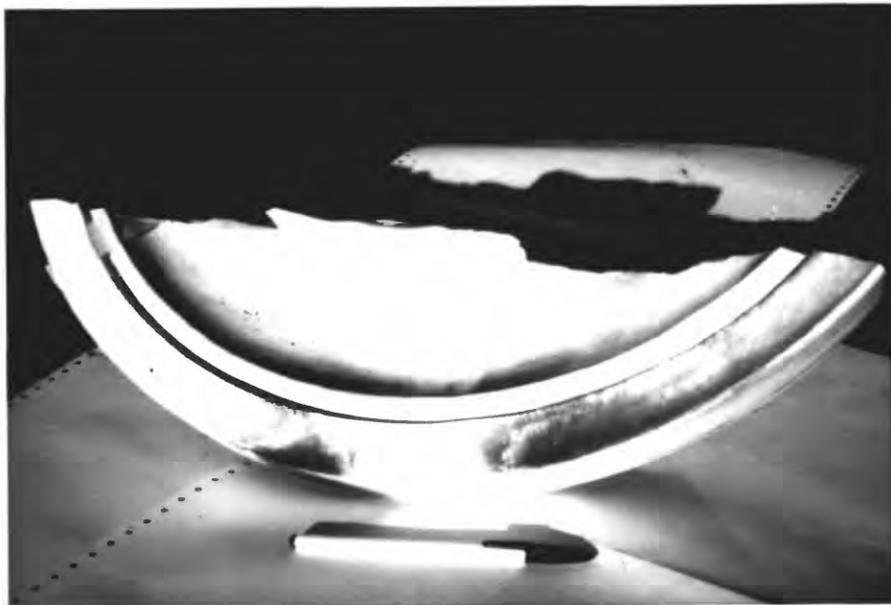
Fig. 5 Photograph of volute piece D from column 12; piece closest to average in size

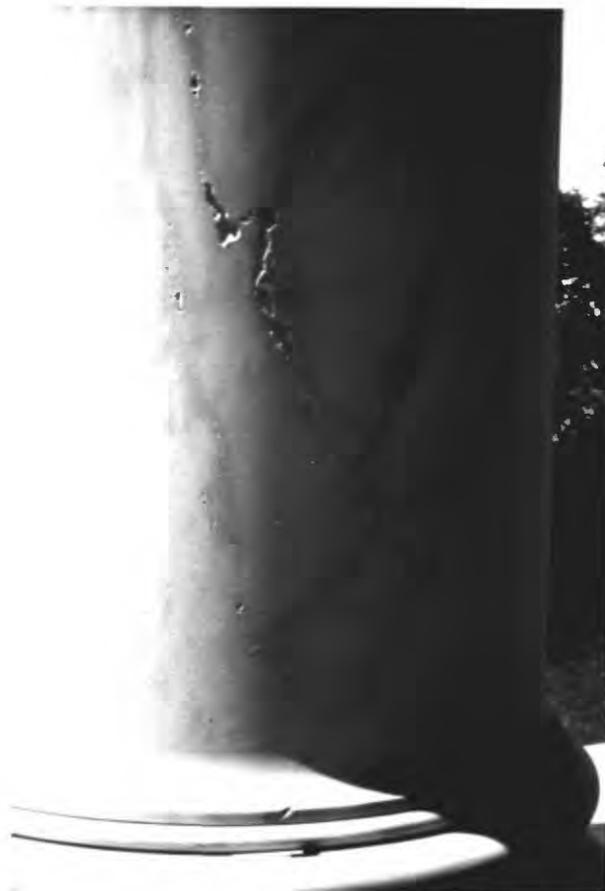
Fig. 6 Column shaft at Jefferson Memorial with preferential weathering along an inclusion trace.

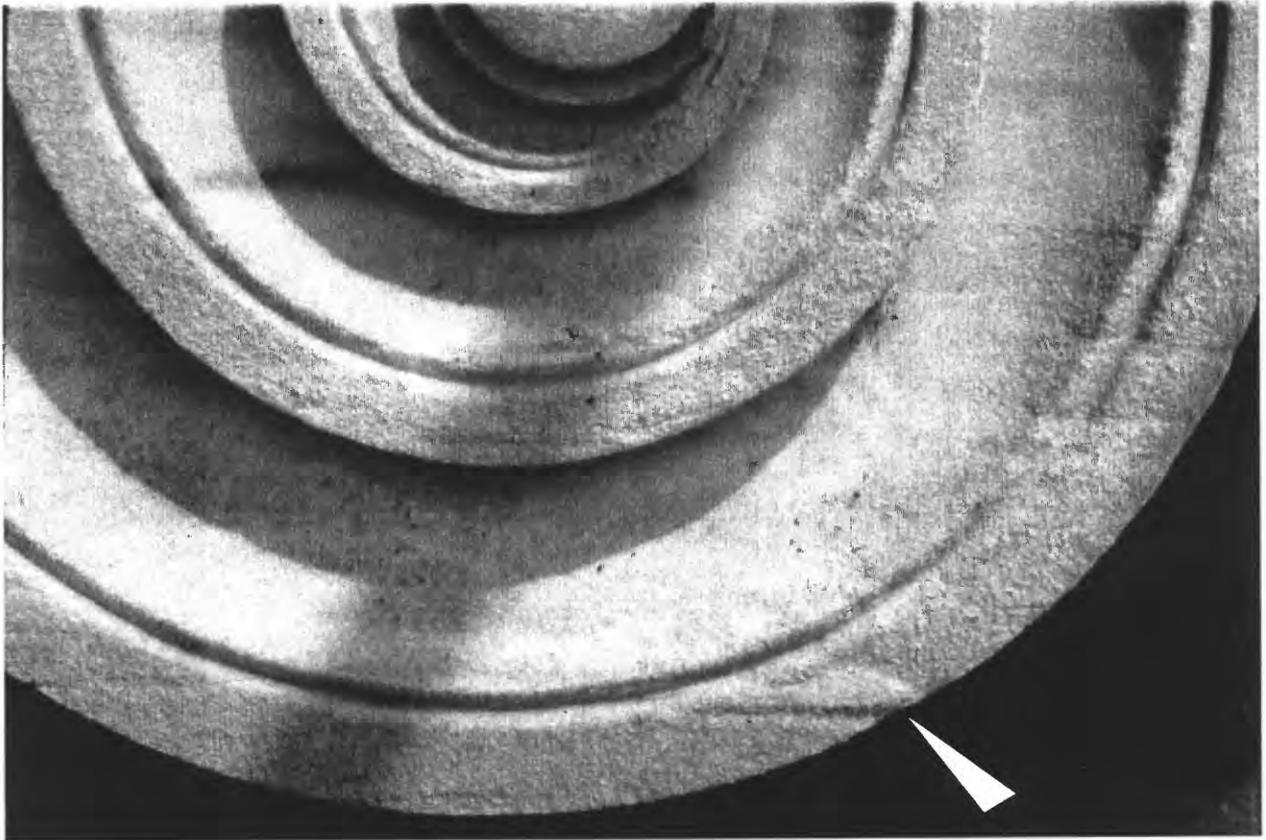
Fig. 8 Shallow indentations on a volute face, some resemble cracks; lower half of volute 21C.

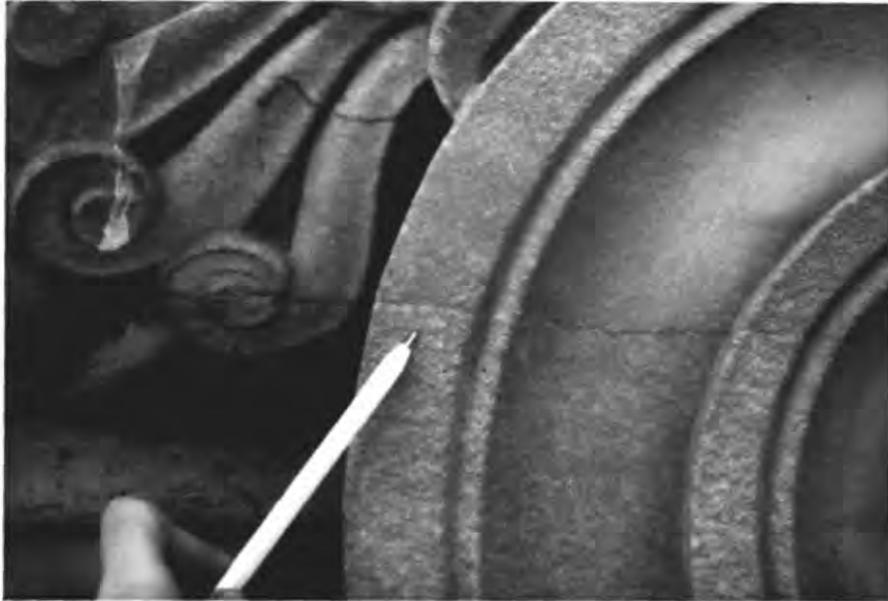
Fig. 9 Some cracks form narrow, linear openings; detail of volute 40B.

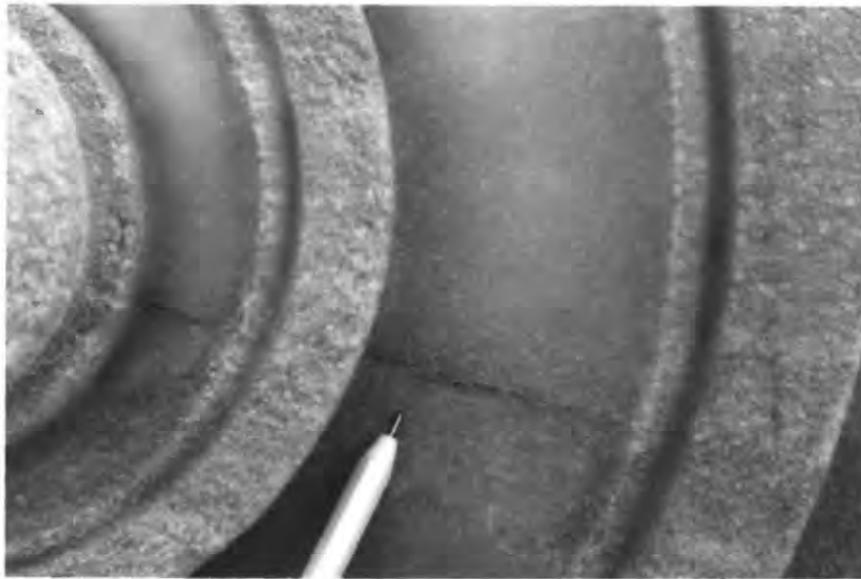
Fig. 10 Cracks that occur in recessed portions of the volute faces are probably are not the result of surface weathering effects on the stone (volute 27B).

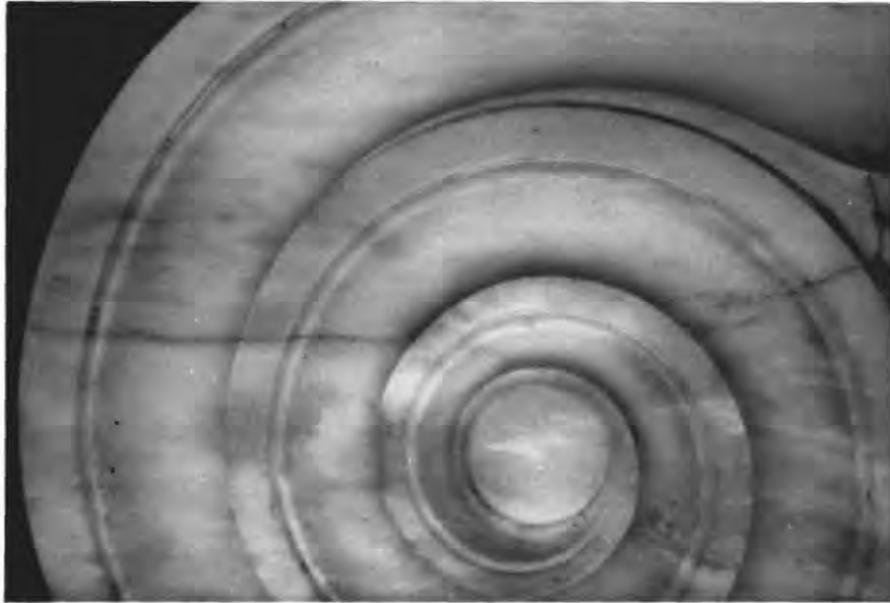
Fig. 11 Photograph of a crack on volute 53C that extends across a rim and a recessed area of the volute face.

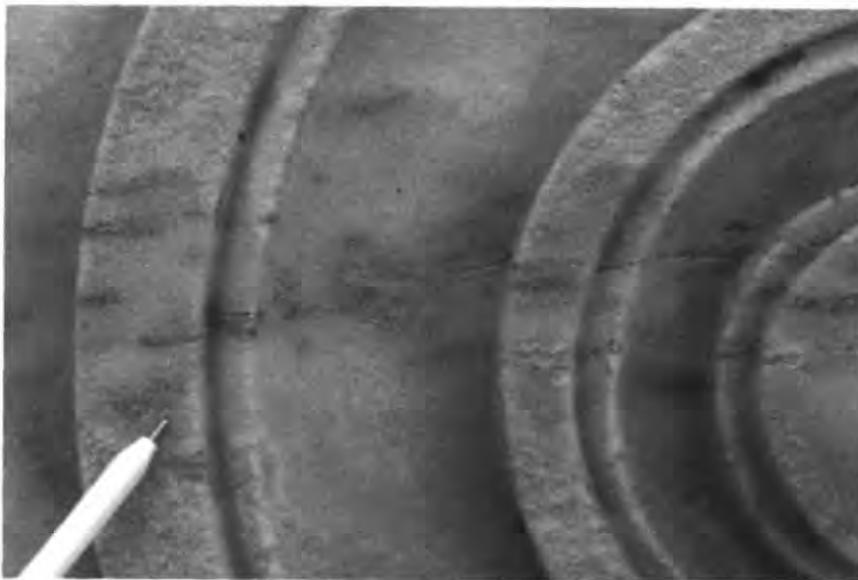
Inclusions are fairly common in the marble of the column capitals. Often the inclusions form thin linear traces that, when accentuated by weathering, resemble cracks. Because of this, an effort was made to distinguish linear weathering features from features that might indicate an impact on stone integrity. Some of the factors used to distinguish cracks from weathered inclusions were: the appearance of an inclusion trace, how deep and extensive it appears to be, whether it is open in a partly sheltered area of the volute, and whether it seems to correlate with other segments along a horizontal line. About 30% of the cracks on the volutes are associated with inclusions in the marble (Fig. 12, Table 3). Approximately half of the type 1 and type 2

Fig. 12 Crack associated with inclusions in the marble on volute 18C.

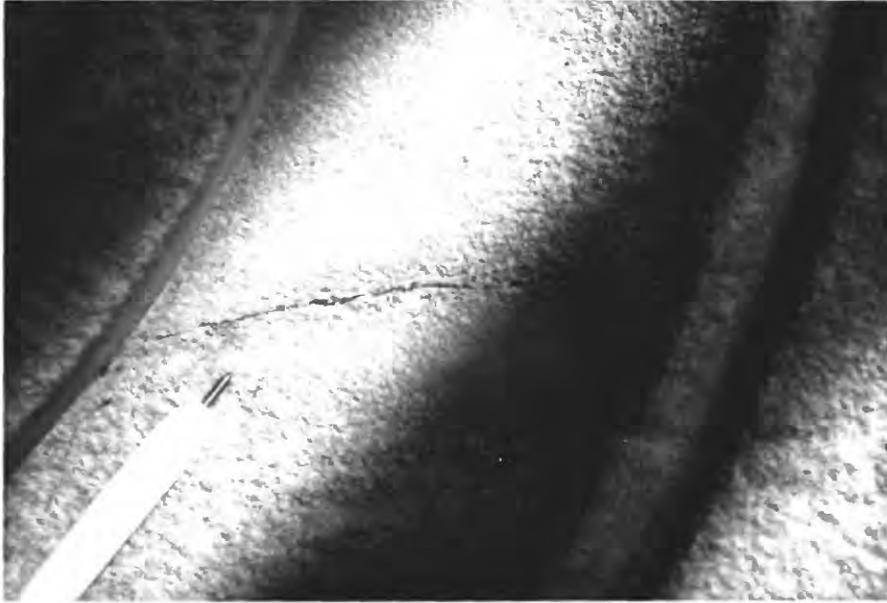
cracks appear to be independent of the mica inclusions; but they occur where the texture (grain size or appearance) of the calcite changes in the marble (Fig. 13, Table 3).

Fig. 13 Photograph of grain size (textural) change associated with a crack in volute 30C.

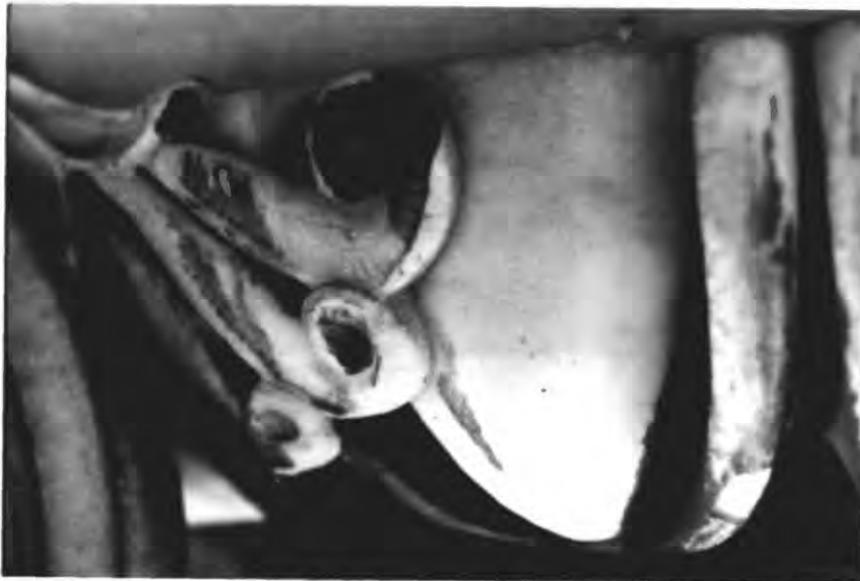
Fig. 14 Portions of the egg and dart trim (on column 19; A-D side) have broken off, revealing sugaring marble under the black surficial crust.

For this study, the crusts are mostly of concern because they obscure surface features of the marble. They are useful however, because their presence shows that a particular area of the column capital has not been exposed to much washing from water. In addition to disfiguring the memorial, the crusts may cause problems because the marble under the crusts tends to disaggregate. Despite the relatively young age of this memorial, where the blackened stone is chipped, the freshly exposed stone crumbles easily when it is touched (Fig. 14).

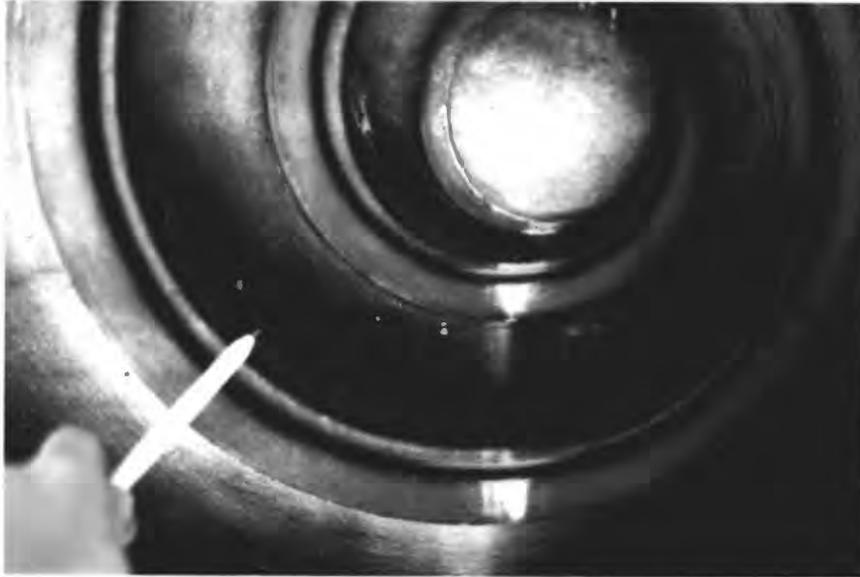
Fig. 15 The crack in volute 10 C is horizontal, in the recessed portion of the lower part of the volute, and it is co-planar with the fracture face in the adjacent, broken volute (10B).

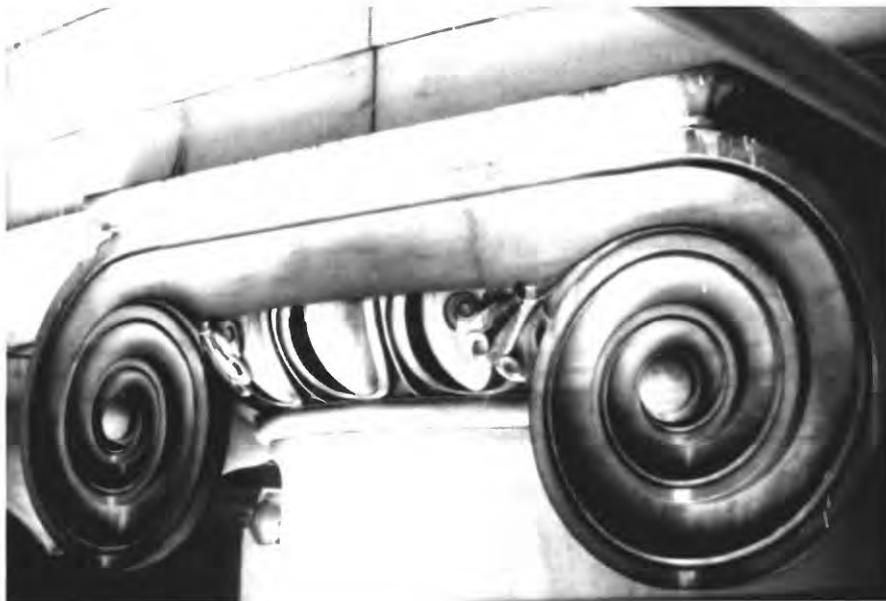
Fig. B-1. Volutes B and C on column 8 show the typical distribution of blackened surficial crusts on a sheltered column capital.

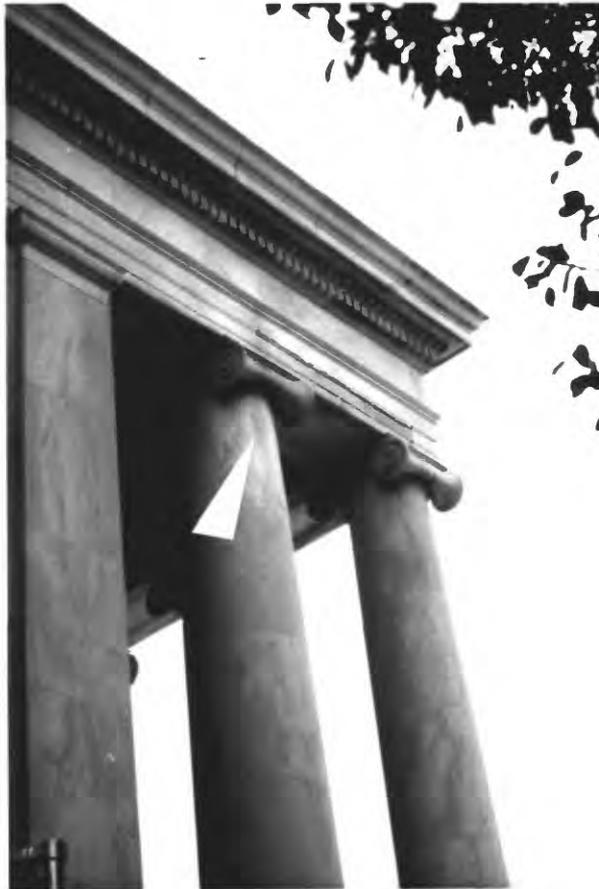
is easily visible from the east side of the memorial (Fig. B-3). Similar, less visible, small areas of this stain are located elsewhere near the top of column 43 and on columns 53 and 54. The stain first appears as a light yellow color; with time it changes to a darker yellow and then to pink. It appears more pronounced in warm humid weather. Close examination of the stain on the column shows that it appears to be concentrated just below the stone surface, and X-ray diffraction analysis of samples scraped from the discolored area found only calcite. Because the bright discoloration occurs on columns where there may be excess moisture from the roof, and because the stained area appears to change in size with time and humidity, it was suggested that the stain might be of biologic origin. A sample was collected and cultured, and a filamentous bacteria was found in it (written communication to A. Donald, DCS-NPS, 10/31/95). David Kennitzer (Einhorn, Yaffee, and Prescott; oral communication) identified a micrococcus roseolous bacteria in a similarly stained area at the Arlington Memorial Amphitheater. It appears that the bright discoloration at the Jefferson Memorial is probably the same type of bacteria.

Fig. B-3. The bright pink/yellow stain is visible on the side, near the top of column 43 (center of photo) even from some distance away.

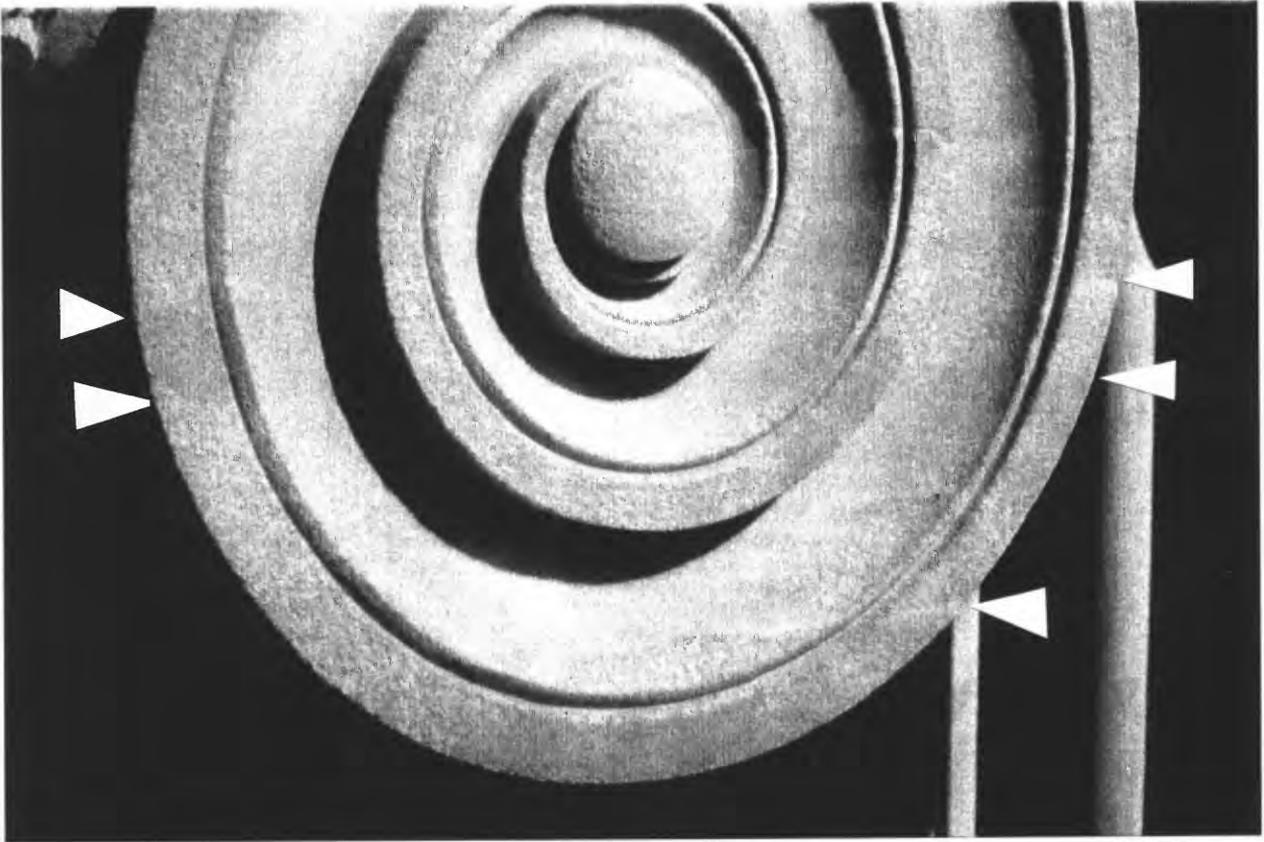
The textural change revealed by the bands is horizontal and appears to be extensive; it is continuous and visible across the two outward facing volutes on the column capitals where it occurs. However, the textural change is not visible on the sheltered sides of the column capitals where the stone surface has not been roughened by weathering and details of the marble are partially obscured by surficial alteration crusts. Cracks in some column capitals (eg. 33B, 32C, 30C, 27B) are associated with textural changes in the marble that are similar to the textural change on the column capitals with the bands of buff and gray stone. It seems that such a textural change indicates that there are horizontal planes in the marble that may differ in strength and might contribute to the failure of a volute in the right situation. Two of the column capitals where the banding was quite noticeable (#29 and 30) have broken volutes, suggesting a correlation between the bands and a weakness in the stone. However, on column 29 there is also a significant concentration of phlogopite inclusions on the fracture plane so in this case it is unclear whether the texture, the inclusions, or both influenced the failure of the volute.

Fig. C-1 Volute 30B has buff and gray bands that appear to have differing surface textures.
